Massachusetts Department of Environmental Protection Bureau of Resource Protection – Watershed Permitting Program Sanitary Sewer Overflow (SSO)/Bypass Notification Form

061218 - Pump Station A

Town of Hull Wastewater Treatment Plant

Unauthorized Discharge Summary Pump Station [LS A] [6-12-18]

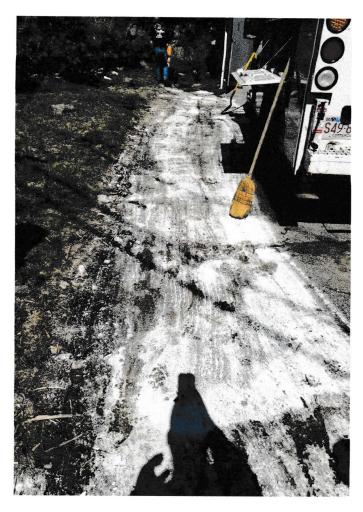
6-12-18 LIME APPLIED TO ALL AREAS

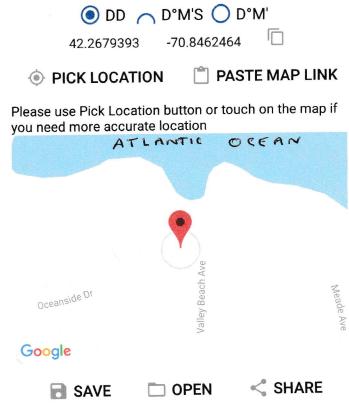
Cause of the unauthorized discharge, (blockage or break; mechanical, electrical, or structural failures);	Failure of drain back valve
If caused by a blockage, identify the type of blockage (e.g., grease, rags, debris);	NA NA
If caused by a mechanical, electrical, or structural failure, the date of the last inspection, maintenance, or repair of the failed asset;	Component used approximately 3 months earlier on 3/13/18.
Did the release reach any portion of the Town's Municipal Separate Storm Sewer System ("MS4").	No release to MS4; no storm drains in this area.

REPAIRED DER VALVE
AFTER REPAIRS G-13-18
